Re: 26247 North Paso Trail, Scottsdale AZ 85255 - Example of Resale Home Inspection Report

INSPECTION CONDITIONS

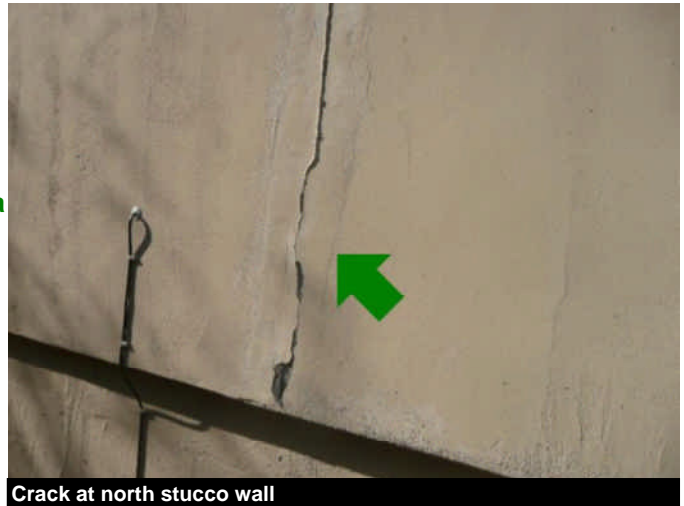
- a) Large Cracks observed at north side exterior wall area below the window
- b) Damaged wall at north side below the electrical panel.

- a) Large Cracks observed at north side exterior wall area below the window
 - b) Damaged wall at north side below the electrical panel.
- Recommend Repair walls to prevent further deterioration and possible water intrusion and damage.

Crack at north stucco wall

Recommend Repair walls to prevent further deterioration and possible water intrusion and damage.

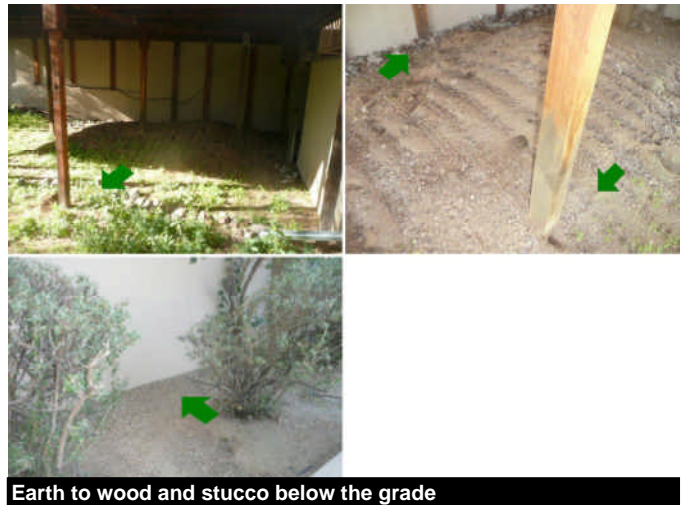
a) Recommend lowering soil/gravel below siding at west planter by the garage. Grade should be 6 inches below any stucco or wood materials to prevent pest intrusion.

b) Recommend eliminating earth-to-wood contact at north east wood decking columns to prevent pest intrusion.

Earth to wood and stucco below the grade

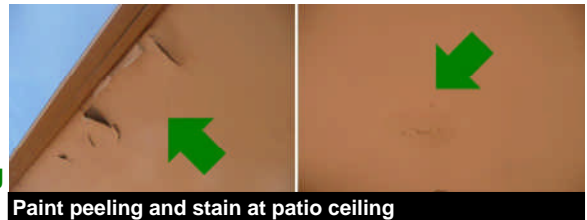
Stains and paint peeling observed at east patio ceiling area.

Paint peeling and stain at patio ceiling

Recommend Monitor and Repair as needed.

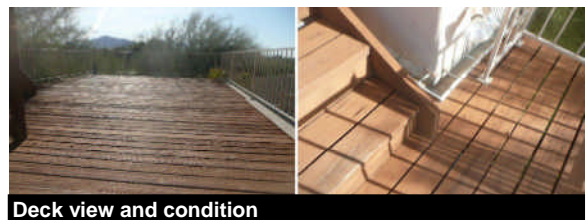
Noted several loose boards observed at rear yard area.

Deck view and condition

Recommend securing loose boards. Typical Maintenance Type Repair.

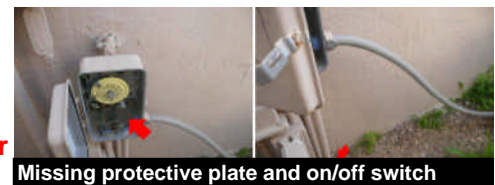
a) Terminal protector cover is missing from within equipment timer unit. SAFETY HAZARD!
 Recommend installation as is required.

b) No manual ON/OFF switch observed installed for operating pool pump. A qualified pool contractor should be called to make further evaluation and recommendations for repair or replacement of the condition(s) observed.

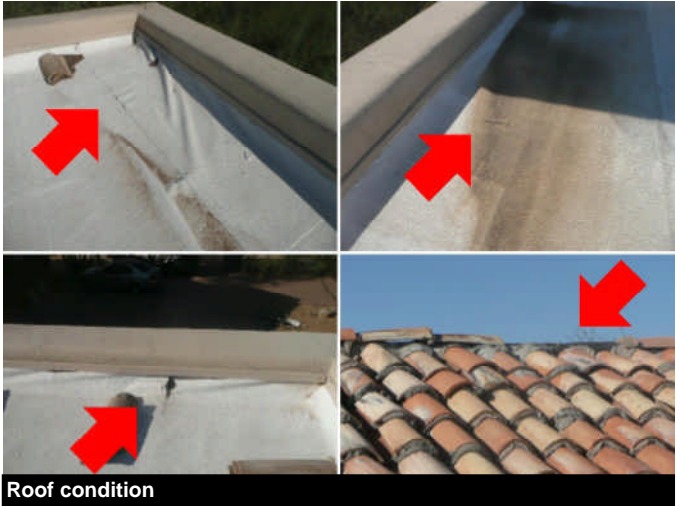
Rolled Composition roofing observed in good condition/within useful life with the following noted exception (s):
a) Deteriorated top coating and improper roof material installation observed above the garage roof area under the parapet wall.

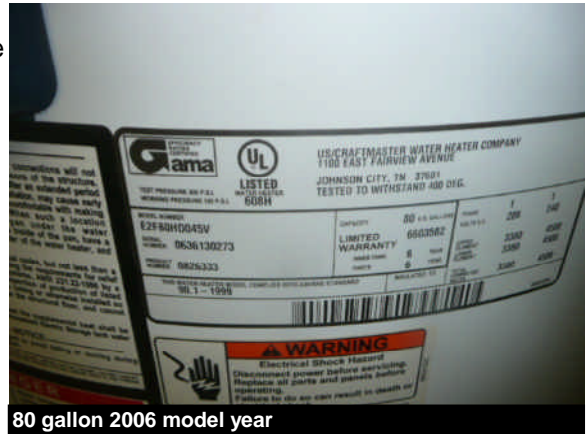
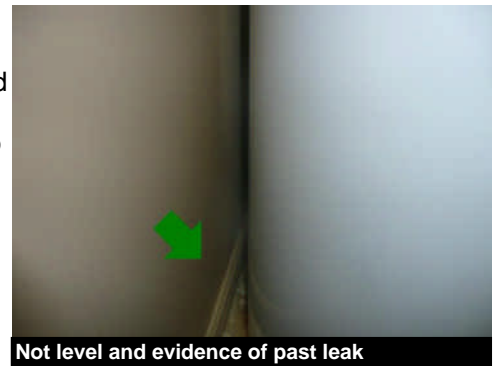
SIZE: 80 Gallons.
LOCATION: Laundry room utility closet.
CONDITION: Pressure relief valve noted properly installed. Not tested.
A water shutoff valve is installed, tested operable.
Water heater unit provided hot water to house at inspection and Water Heater Unit observed in good condition with the following noted exception(s):
a) Water heater Unit observed to be tilted due to damaged baseboard caused by past leak. Recommend repair/level to insure proper operation.

b) Evidence of past leak observed around the water heater wall and baseboard area.

c) Corrosion is observed at inlet piping. No active leaking observed at time of inspection. Recommend Monitor and Repair as needed.

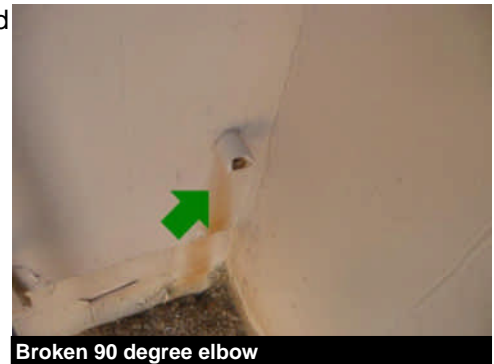
90 Degree elbow is broken/missing from Condensate Drain Line.

Recommend installation for proper CDL drainage.

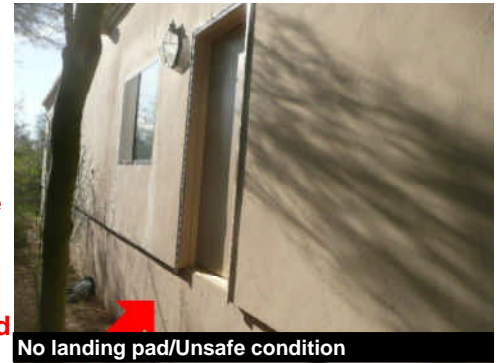
NUMBER OF DOORS One service door.
CONDITION: **a) Door service door was locked at the time of inspection and could not test. Review operation prior to close. Repair as needed.**
b) Unsafe condition observed at north exterior side of garage service door. No landing pad/steps observed installed. We recommended further review and evaluation by a licensed contractor prior to close. Repair if required.

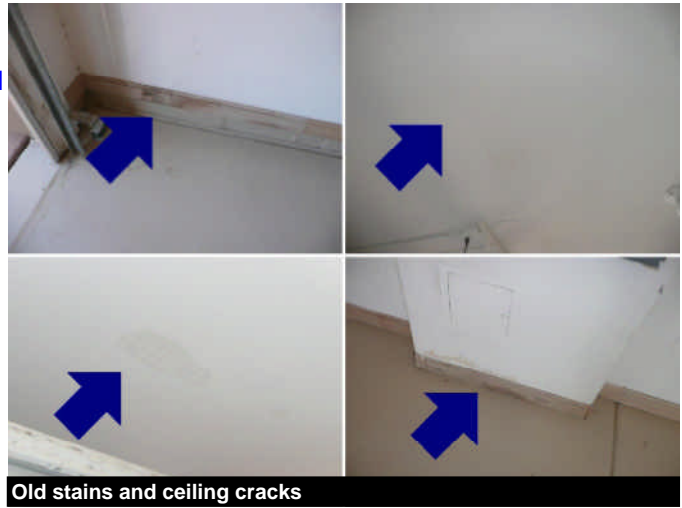
Typical Ceiling Crack observed.
Old Stains and typical type settling cracks noted at the Garage ceiling and base board areas. Unable to determine cause of stains. Appears to be older stains. Recommend monitor and repair as needed.

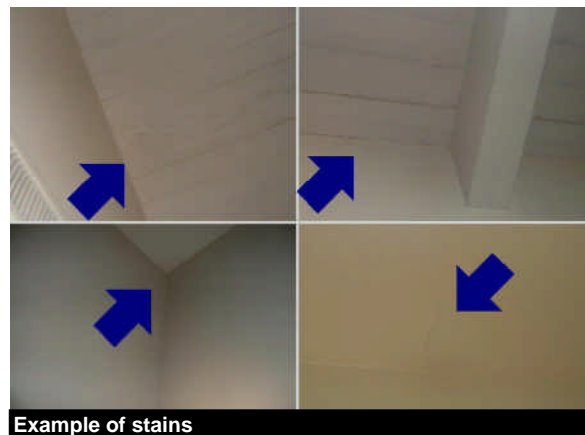
TYPE & CONDITION: Drywall, Wood
All ceiling areas observed in good condition with some typical cracks observed with the following noted exception (s):
Stains observed at south west room and evidence of possible leaks at master bathroom area.
Due to present dry weather conditions, unable to determine if an active leak exists.
See general roof comments.

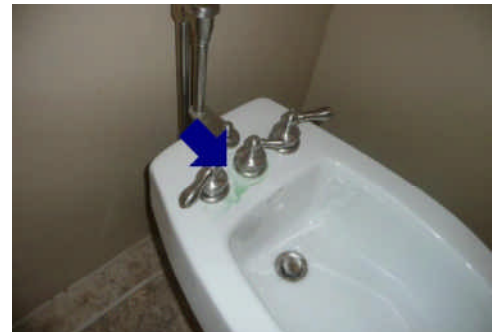
In good condition. Tested operable.
Evidence of past leak observed around Bidet operating valve however none noted at time of this inspection. Recommend monitor and repair as needed.

Evidence of past leak

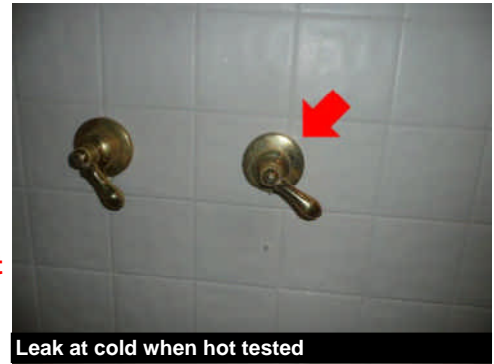
Leak noted around cold water faucet fixture when hot water faucet was turned on.

We recommend further review and evaluation and repair if required by a Licensed Plumbing Contractor.

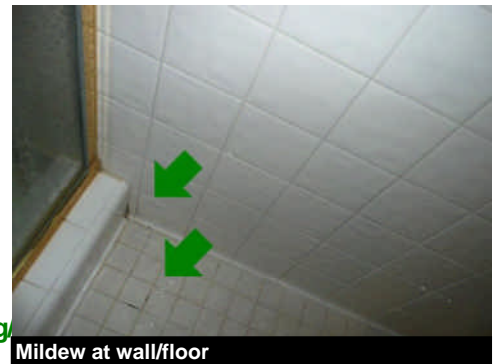
**Evidence of Mildew observed at shower wall/floor.
Recommend cleaning/removing mildew damaged areas and repairing/re grouting any damaged areas.**

Note: Mildew is generally a result of not adequately drying tub/shower surfaces after use either by wiping down or utilizing bath vent for long enough duration to allow for proper drying.
