01/20/2007

Re: 17047 West Carmen Drive Surprise, AZ. 85388 - New Home - Builder Warranty Inspection

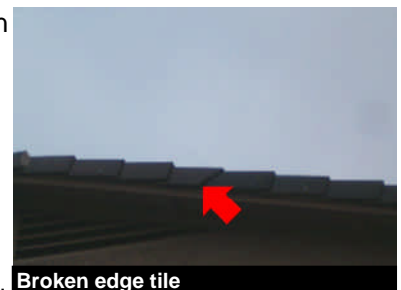
**Broken Tile edge observed at south edge. Recommend Builder Review above noted condition(s) and repair as required.**

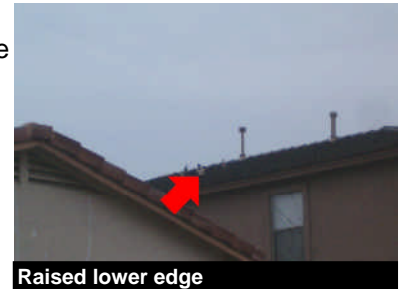
**The lower edges of vent stack flashing appears to be raised on the west and east sides.**

**Recommend Builder Review above noted condition(s) and repair as required.**

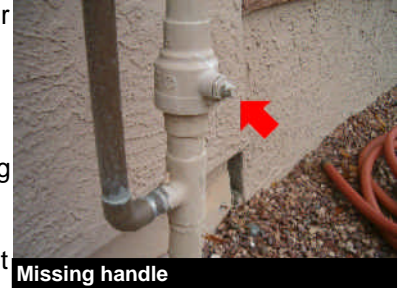
**MATERIAL:** Copper.  
**CONDITION:** Water Shut off valve located at the east exterior side of the house.  
**Water Shut off valve is missing handle. Recommend Builder Review above noted condition(s) and repair as required.**  
 Water Shut -Off Valve not tested due to missing handle.

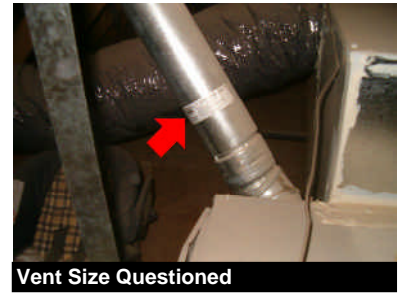
**VENTING:** Observed in good condition with the following noted exception(s):  
**The vent appears to be undersized on the South heating unit. This vent is not the same size as the North unit vent which is larger. Recommend Builder Review above noted condition(s) and repair as required.**

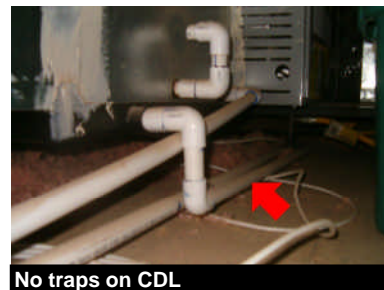
**Both unit's Condensate Drain Lines are missing traps at the attic pans. Recommend Builder Review above noted condition(s) and repair as required.**

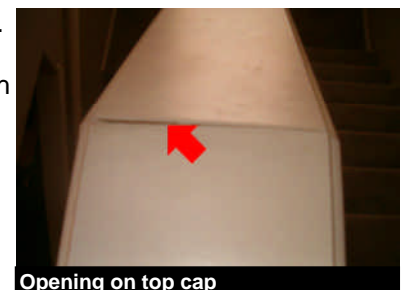
**Openings at the top wood cap on the stairway wall at the top landing area.  
Recommend Builder Review above noted condition(s) and repair as required.**

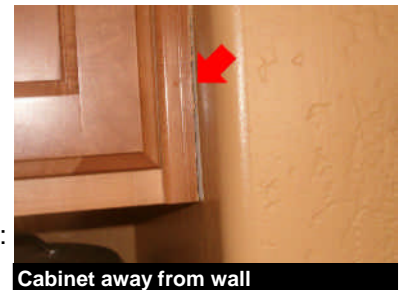
- a. The wall cabinet to the right of the microwave has pulled away from the wall.**
  - b. The base cabinet on the west wall is away from the wall.**
- Recommend Builder Review above noted condition(s) and repair as required.**
