04/25/2007

Re: 13038 West Plum Road Lot #1225 - Peoria, AZ. 85383 - Pre Drywall Inspection

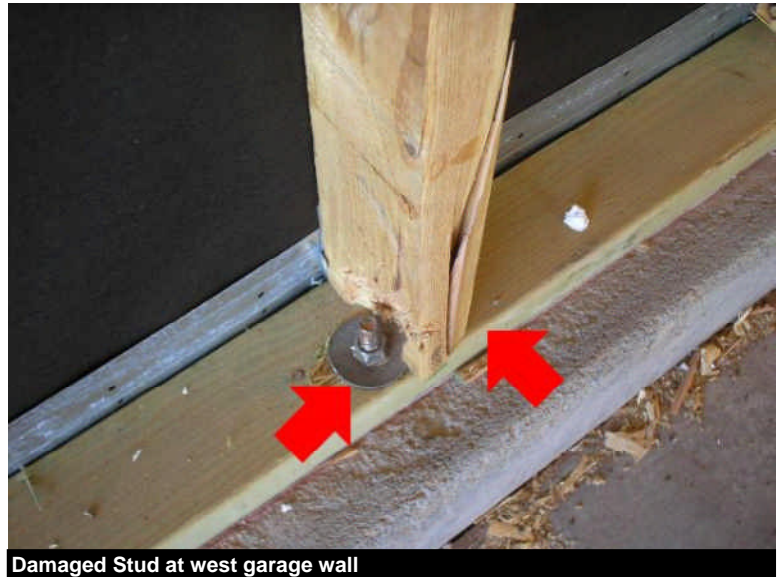
2. Damaged stud observed at west exterior wall of garage due to Anchor Bolt location.

Damaged Stud at west garage wall

**Damaged stud observed at west exterior wall of garage due to Anchor Bolt location.**

Recommend repair by new home builder.

**Recommend repair by new home builder.**

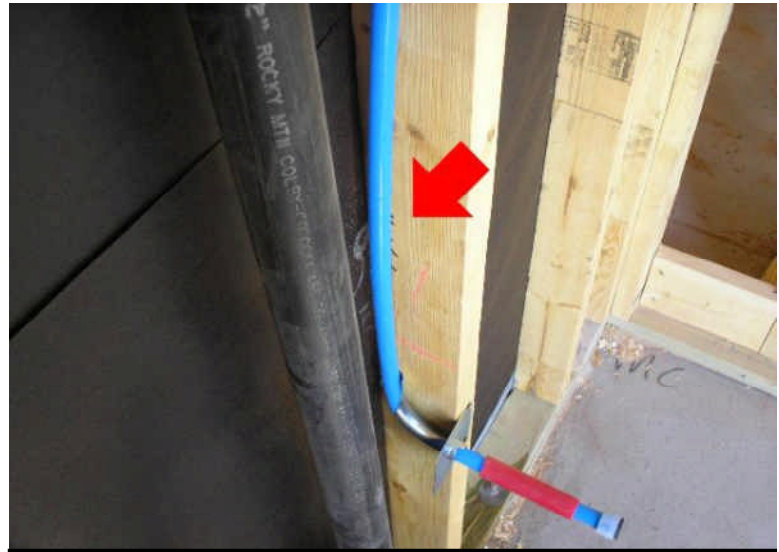
11. Hole observed in cold water Pex type plastic plumbing at Master bathroom west sink. Fasteners from exterior siding installation penetrated line to cause hole in pex plastic plumbing. Note: Inspector notified job superintendent prior to leaving property by phone. Recommend builder replace damaged plastic water line at Master bathroom west sink area prior to dry wall installation.

Exterior fasteners penetrated water line

Hole observed in cold water Pex type plastic plumbing at Master bathroom west sink. Fasteners from exterior siding installation penetrated line to cause hole in pex plastic plumbing. Note: Inspector notified job superintendent prior to leaving property by phone Recommend builder replace damaged plastic water line at Master bathroom west sink prior to dry wall installation.

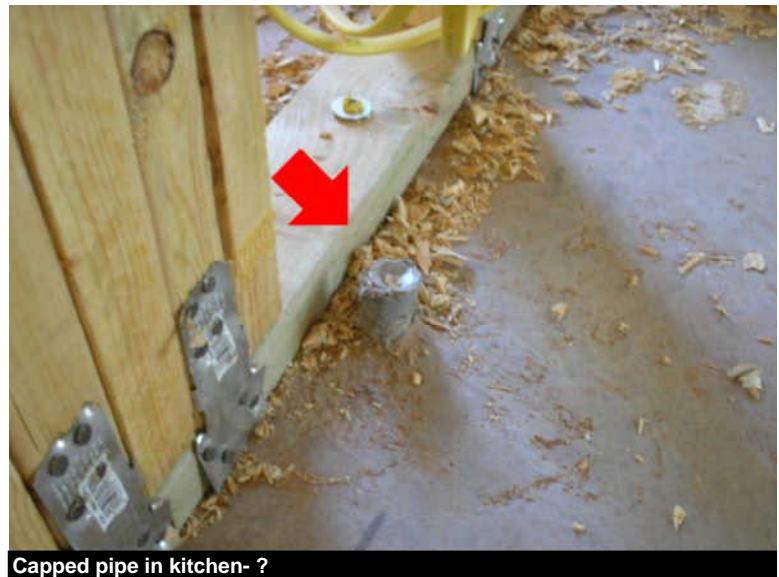
13. Inspector could not identify purpose of capped off pipe through floor (not in Wall) of kitchen to left side of range area. Recommend reviewing with builder purpose of this capped pipe. Repair/Remove if required.

Capped pipe in kitchen- ?

**Inspector could not identify purpose of capped off pipe through floor (not in Wall) of kitchen to left side of range area. Recommend reviewing with builder purpose of this capped pipe. Repair/ Remove if required.**
