Re: 9601 N. Black Canyon Hwy, Phoenix, AZ 85021-2702

REPORT SUMMARY

Report Table of Contents

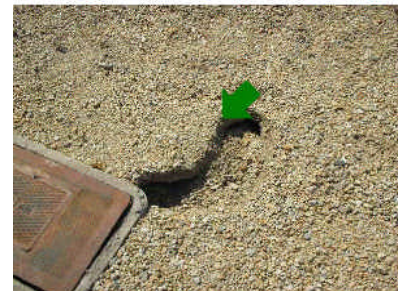
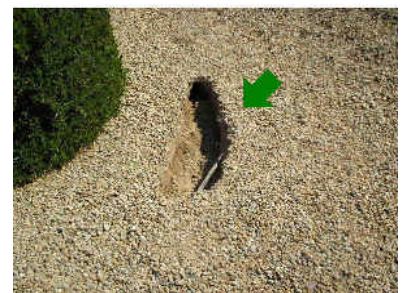
At west yard noted a number of ground areas that show signs of erosion. Recommend fill and monitor.

Holes at west side

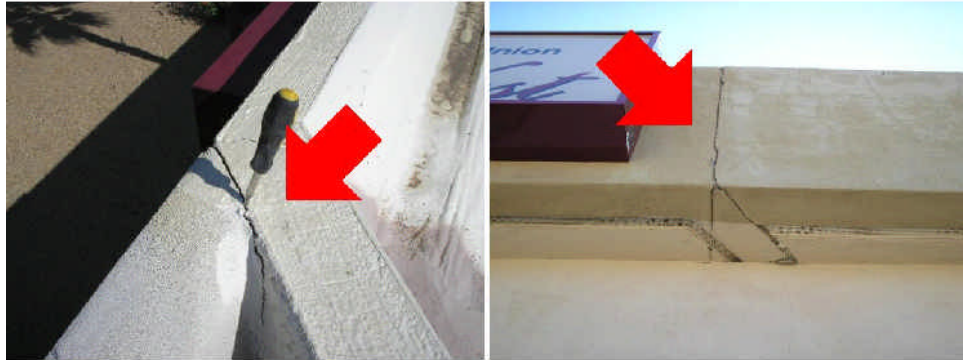
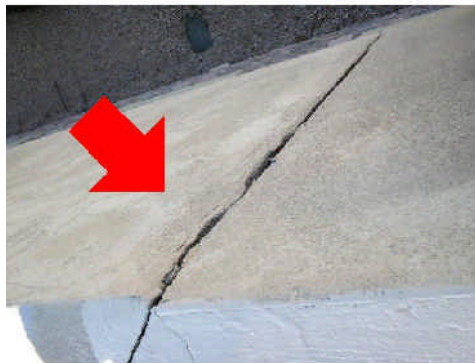
Cracks at masonry wall

Vertical settling cracks are seen at juncture points of some walls of west wall next to sign and NW corner. Recommend patch/repair to prevent further cracking.

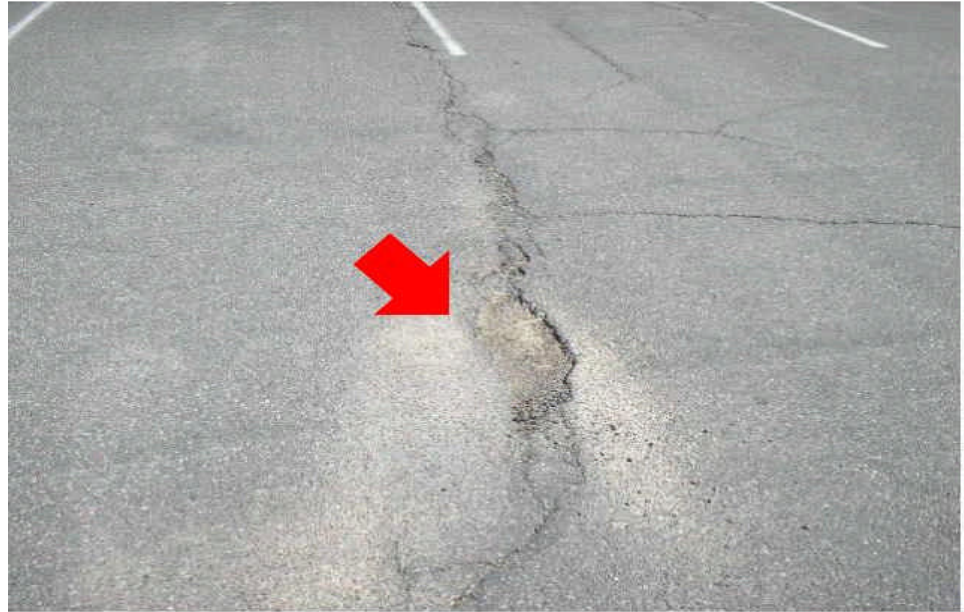
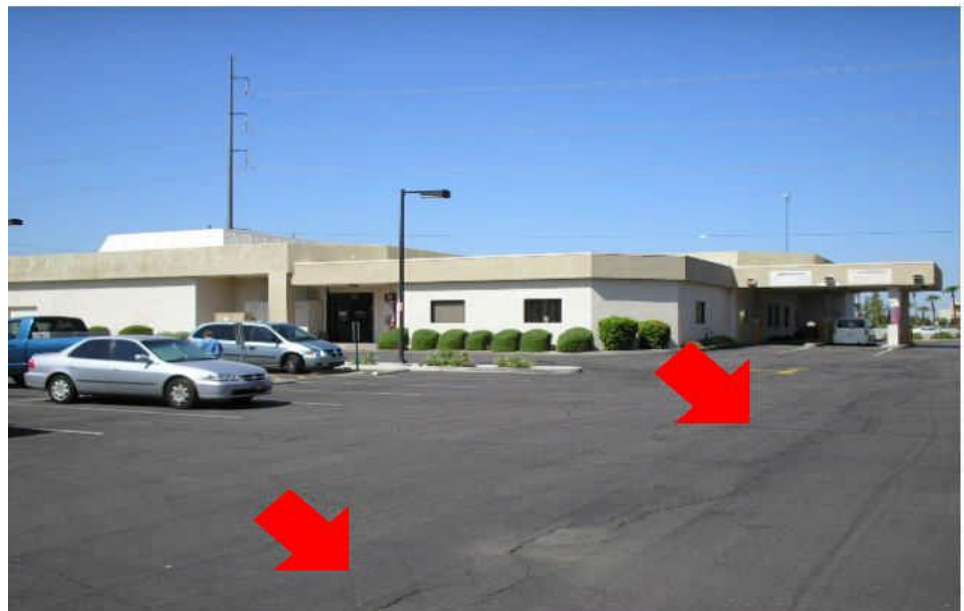
Damaged and cracks

Some expansion cracking is present. Damaged/hole noted at center parking lot.
Appearance of parking area would be improved by seal-coating.

Recommend repair/patch to prevent further cracking and deterioration.

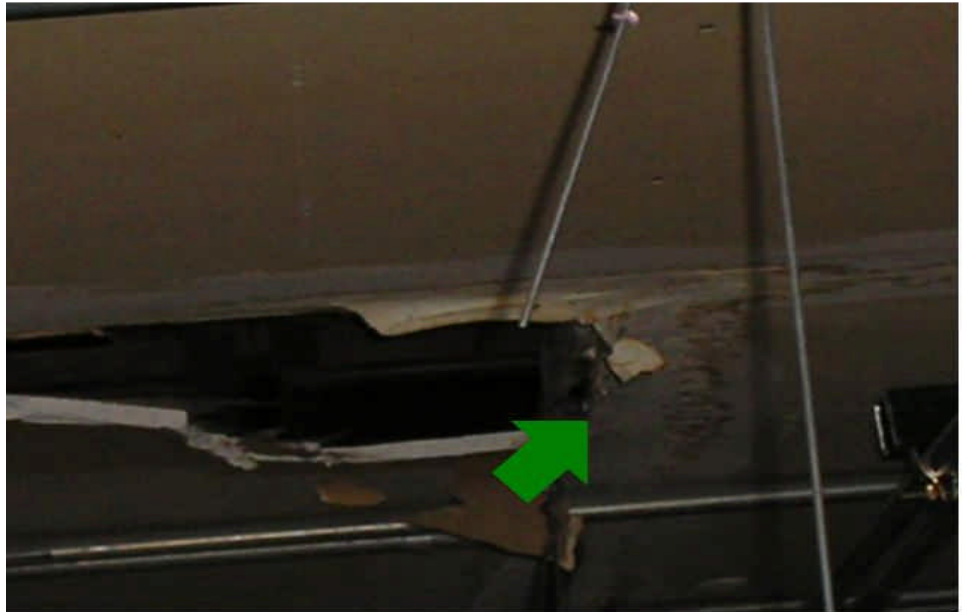
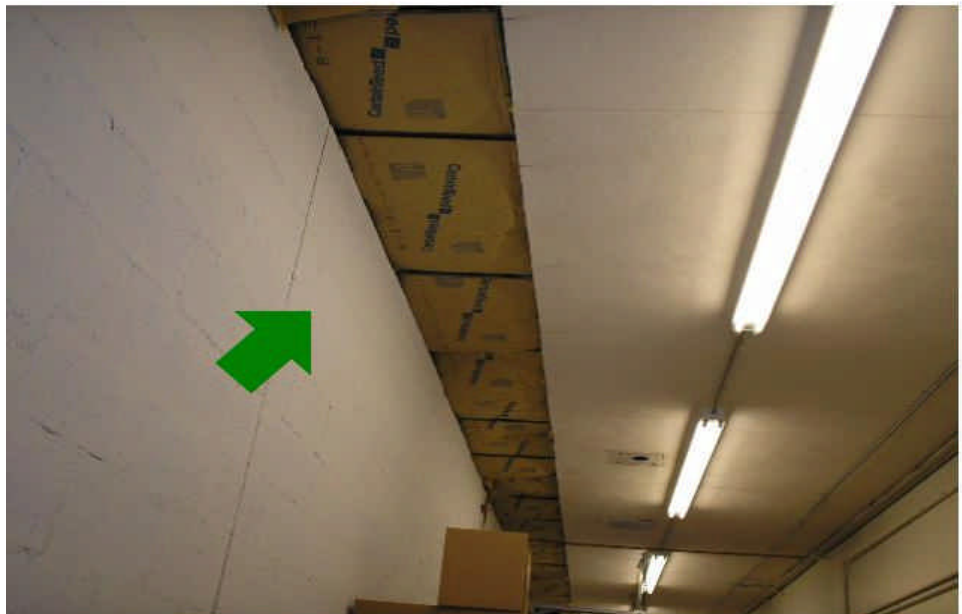
Misture stain and Missing ceiling panel

a: Missing section of ceiling panels/tiles at east storage room with

b: Moisture stain at wall and ceiling at west wall through the opening/wall hole.No active leak noted.

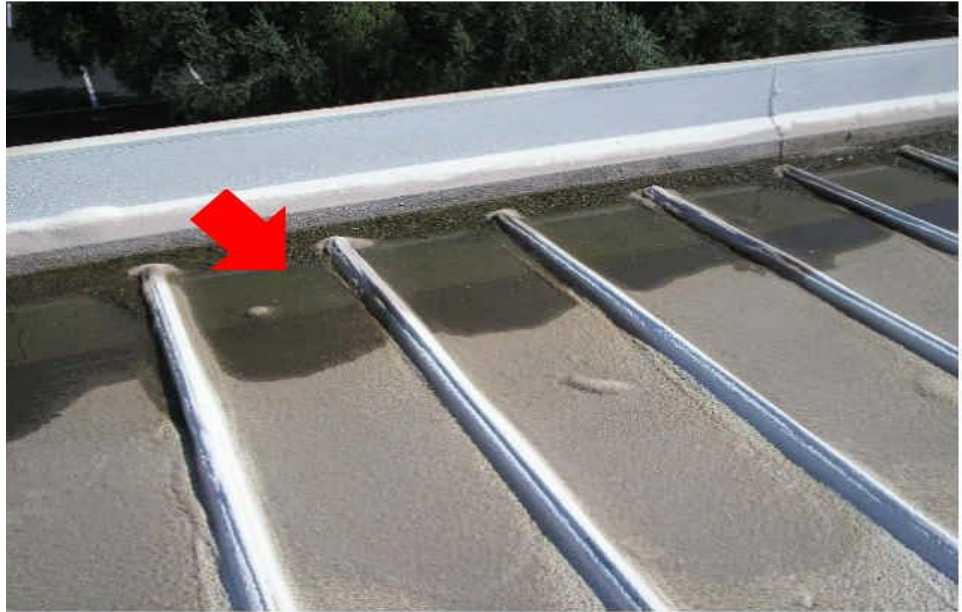
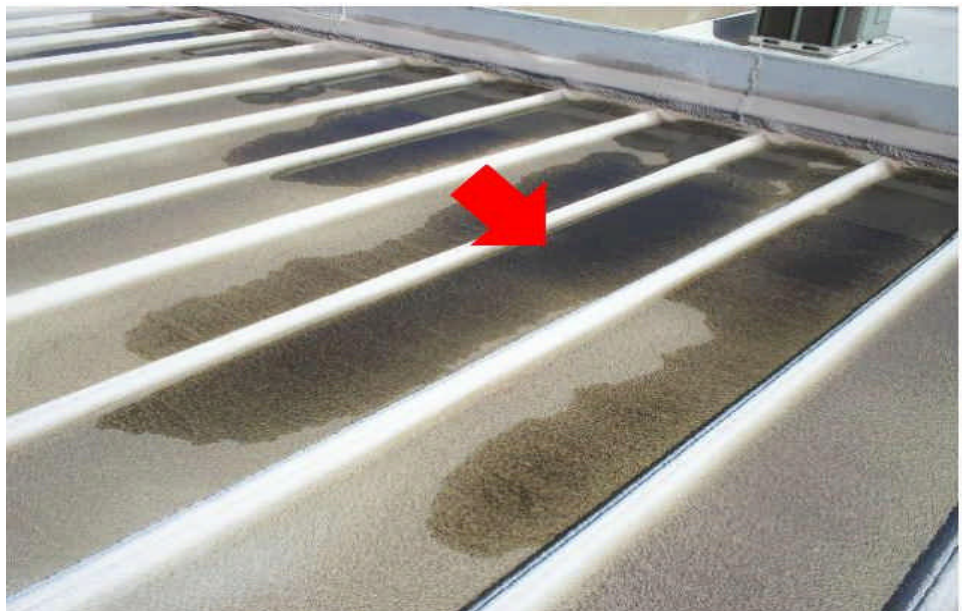
Water ponding and foam bubbles

Several areas of upper and lower roof, bubbles and water ponding noted at east and north side of roof.

A licensed roofing contractor should be called in to make further evaluation and repairs as needed.

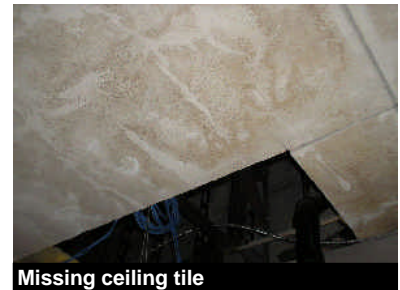
Missing ceiling tile

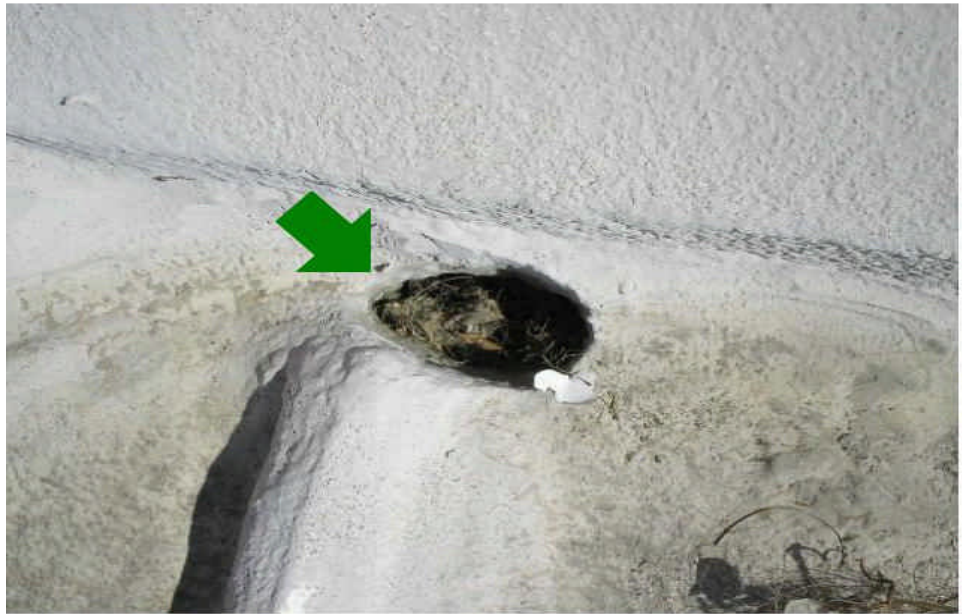
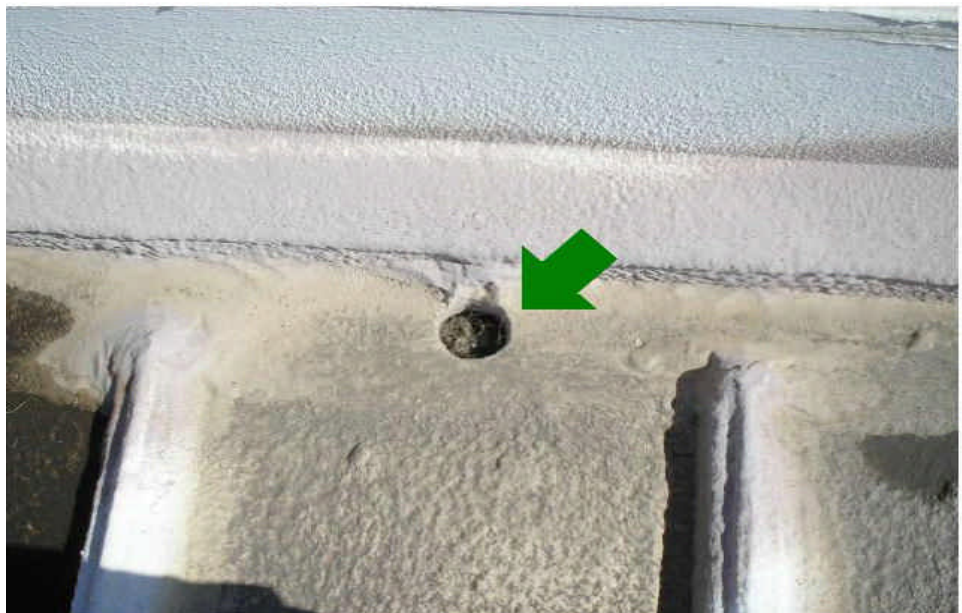
6. Roof drains are full of debris at the north side of structure.
Draining is restricted due to debris and should be cleaned. Typical maintenance repair.

Plugged drain line

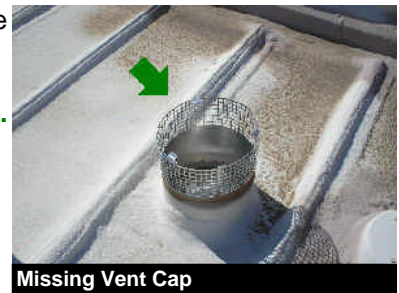
**Missing vent/Rain Cap at south west roof.
Recommend replacing to prevent roof leaks.**

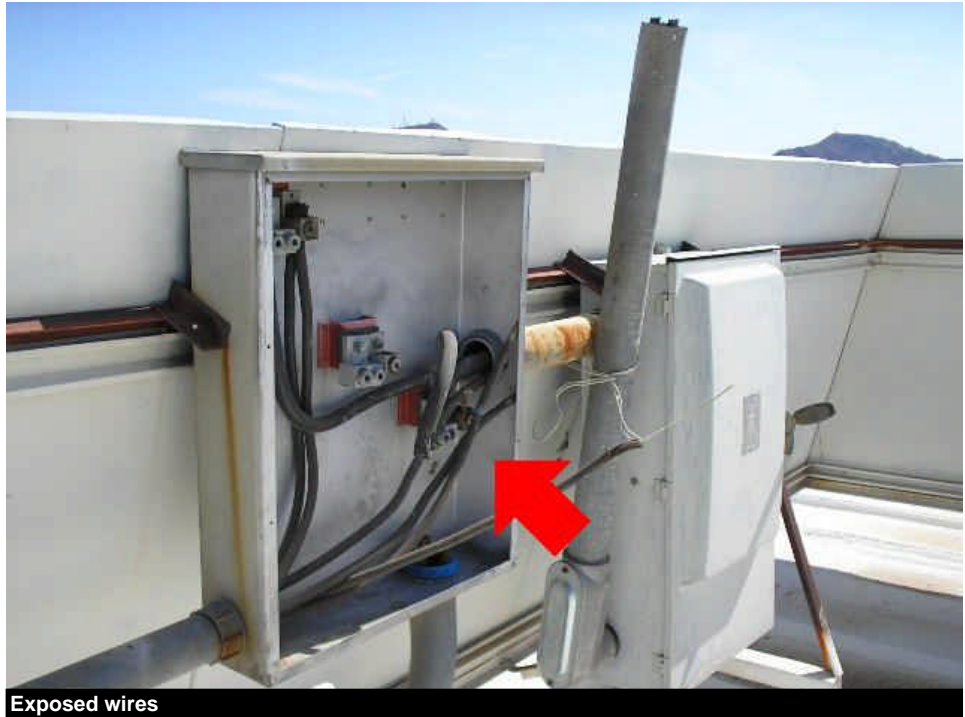
Exposed wires

Cut wires and missing junction box cover noted at north side of roof A/C units.

While this appears to be old wiring and does not appear to be in use, we recommend reviewing with seller for the history of electrical and repair if needed

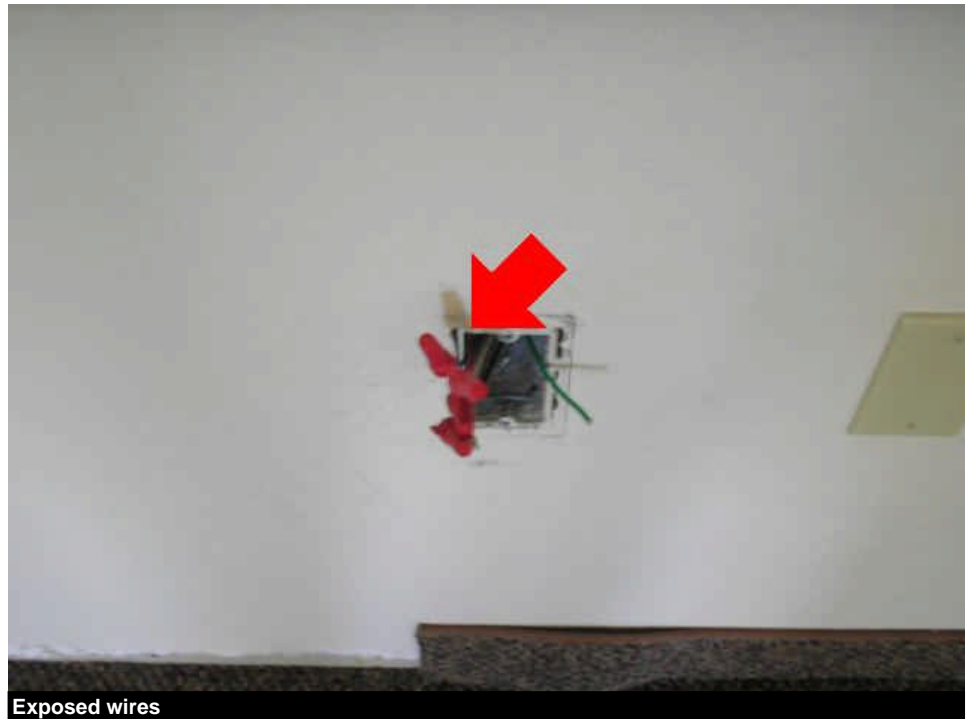
5. Exposed wires at a few electrical outlets at south room next to board room.
Recommend installing outlet plates to cover exposed wires. Safety concern.

Exposed wires

Recommend installing outlet plates to cover exposed wires. Safety concern.

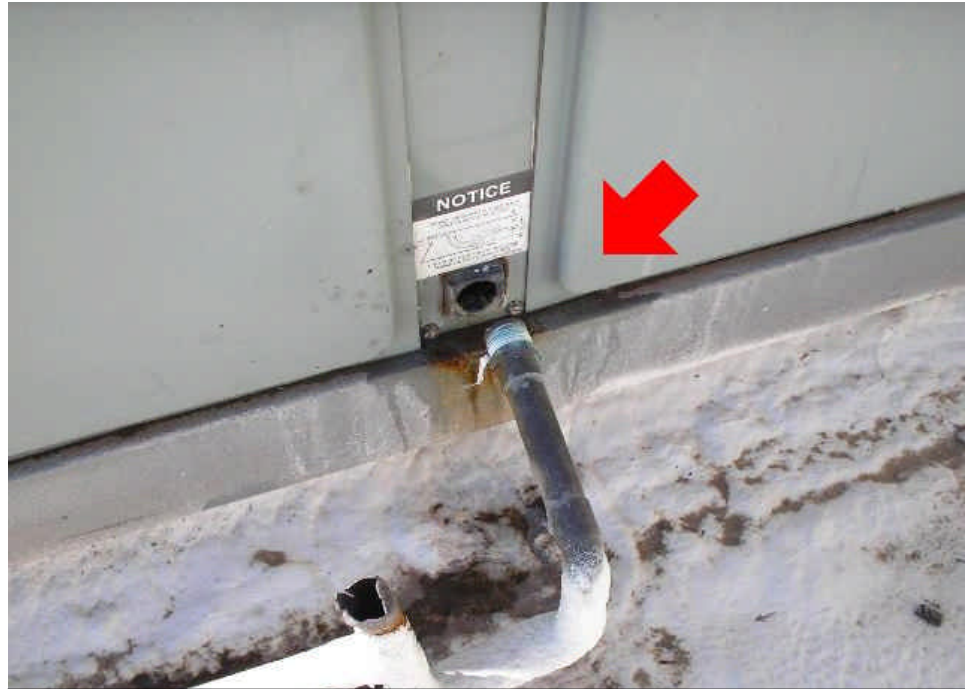
Loose condensate drain

South unit condensate drain line was loose at the unit and draining on top of roof.

Further evaluation and recommendation for repair is needed by a licensed air conditioning contractor.

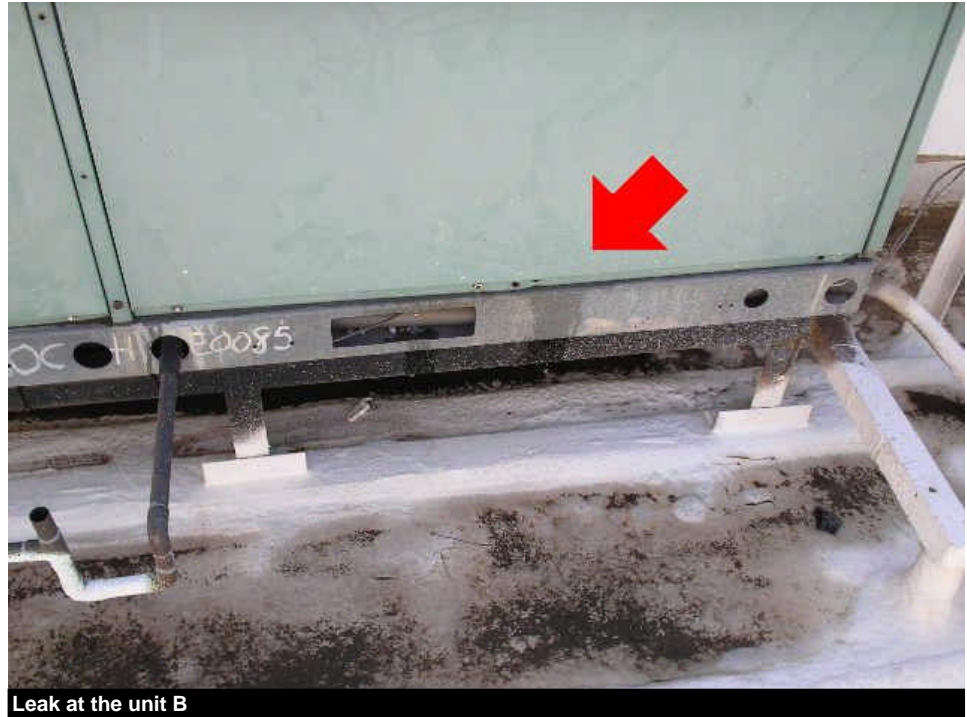
Leak at the unit B

Two 3 ton units.
1988 dated units, 18 years old. Units are at end of normal life. (Average life is 15 years)
Condensate leak noted all around the unit on top of roof.
Further evaluation is needed by a licensed air conditioning contractor.
You should anticipate a recommendation for air conditioning system replacement from the air conditioning contractor, as any repairs would be short term, while replacement would insure proper operation of the air conditioning system on a permanent basis, at a lower operating cost.

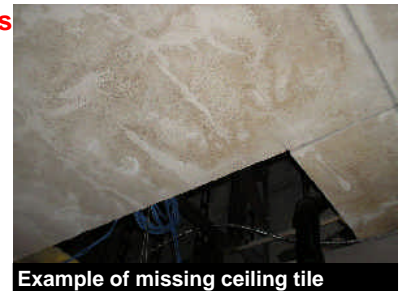
Noted that a number of acoustic ceiling tiles are out of place, missing or stained throughout the building. Recommend replacing all missing and damage ceiling tiles. Note: Missing tiles are a source treated air loss.

Example of missing ceiling tile

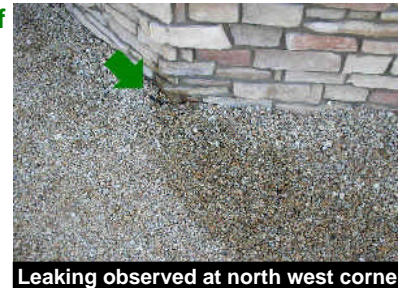
Type: PVC.
Anti -Siphon Devices Properly installed. Good condition.
Minor Leaks? **Line Leaks observed at north west corner of building. Repair recommended**
