Re 20225 East Poco Calle Drive Queen Creek, AZ. 85242 - New Home Inspection

REPORT SUMMARY

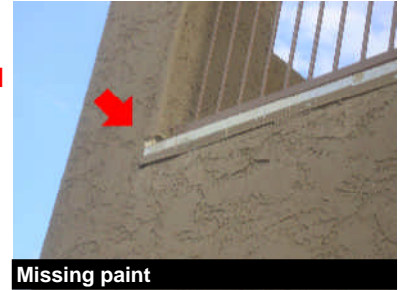
Paint is missing and/or discolored observed at bottom metal flashing.

Recommend Builder Review above noted condition(s) and repair as required.

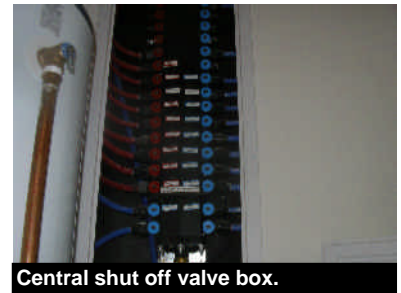
Central shut off valve box.

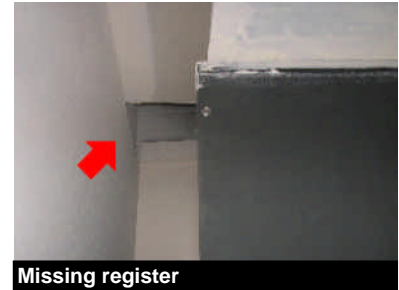
- a) Inadequate air supply source, unable to locate bottom fresh air make up source at upstairs master bedroom unit.
- b) Missing register at ceiling air supply source at master bedroom unit observed. Recommend Builder Review above noted conditions at upstairs master bedroom heating unit and repair as required.

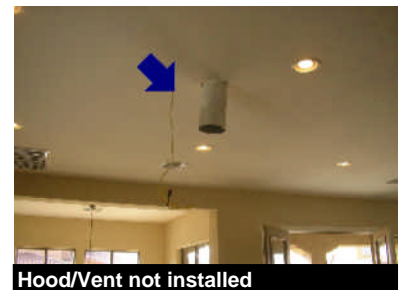
**Vent hood Not installed at the time of inspection.
Review operation of ventilation with builder after installation.**

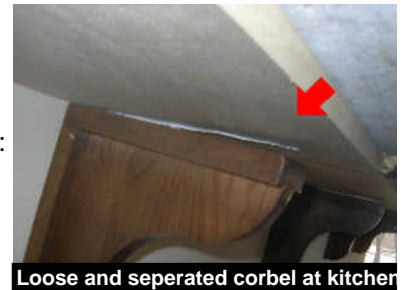
17. Corbels at west kitchen bar counter are loose and counter is separating from support.

Counters are Granite, Counters observed in good condition. No damage or deterioration noted.
Kitchen cabinets observed in generally good condition with the following noted exception (s):
Corbels at west kitchen bar counter are loose and counter is separating from support. Recommend Builder Review above noted condition(s) and repair as required.

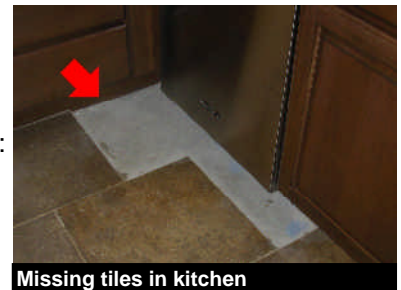
18. Few floor tiles are missing by the dishwasher.

Walls and ceilings observed in good condition. No damage observed.
Floor covering is tile type.
Kitchen flooring observed in generally good condition with the following noted exception (s):
Few missing tiles by dishwasher. Recommend Builder Review above noted condition(s) and repair as required.
