Re: 26247 North Paso Trail, Scottsdale AZ 85255 - Example of Resale Home Inspection Report

INSPECTION CONDITIONS

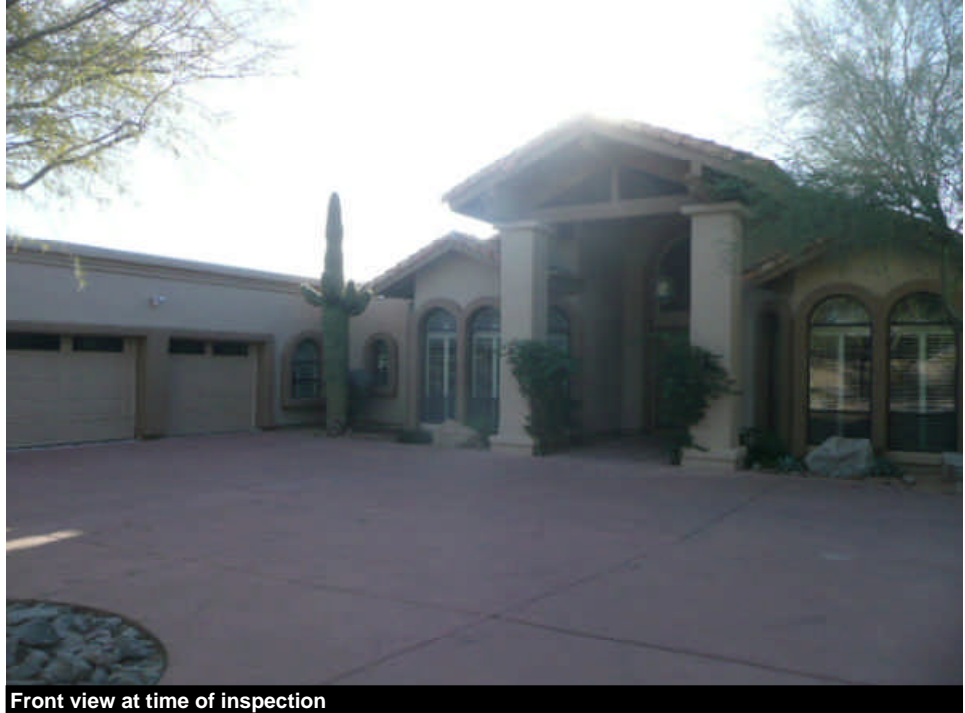
Front view at time of inspection

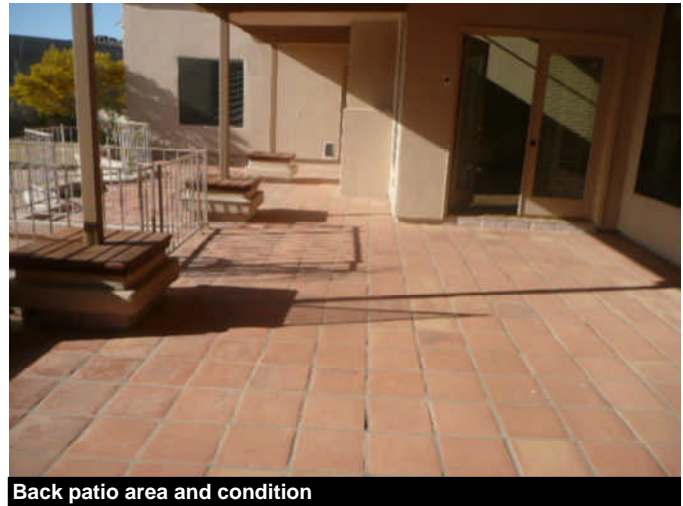
LOCATION : Rear Yard.
MATERIAL TYPE: Tile.
CONDITION: In good condition.

Back patio area and condition

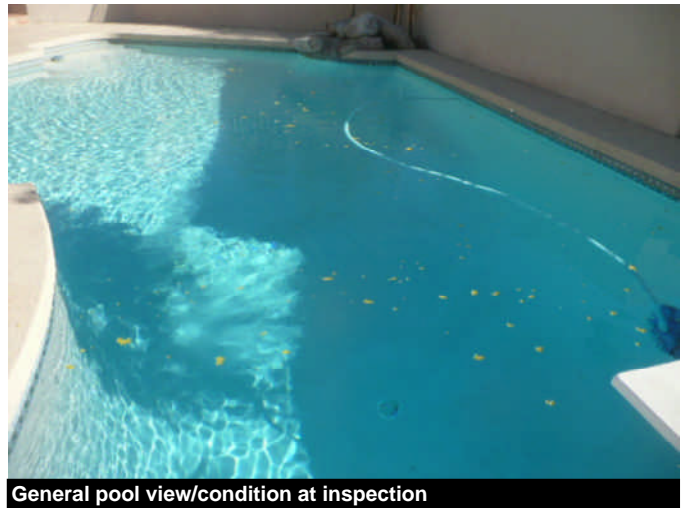
General pool view/condition at inspection

CONDITION: In good condition. No damage or deterioration observed.

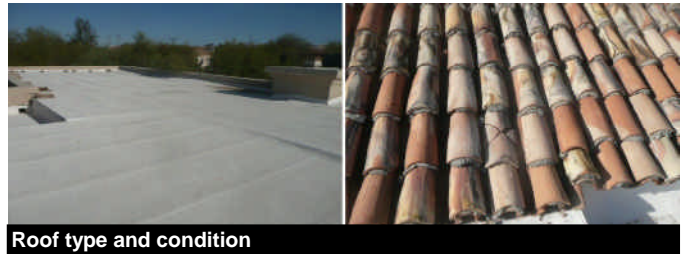
a) Deteriorated top coating and improper roof material installation observed above the garage roof area under the parapet wall.

b) Several broken and missing roof tiles observed at front entrance edge, ridge tile, and north side. Recommend further evaluation tile roof areas by a licensed contractor and repair as required.

Roof type and condition

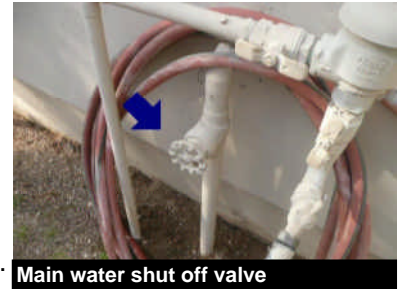
MATERIAL: Copper.
CONDITION: Water Shut off valve is located at, at the north exterior side of the house. Water Shut-Off Valve tested operational, Water pressure appears adequate measured at 80 PSI, within normal range. (normal range is 45 - 80 PSI).

Pressure Regulator is installed for adjustment of water pressure. Observed in good condition.

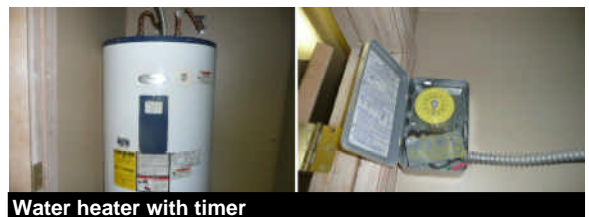
TYPE: Electric type water heater unit with Timer control.
Note: Timer is used for On/Off only. No pins/cogs installed at timer control for automatic operation. Install pins as needed for automatic water heater operation.

AGE: 2006 dated Unit. 3 years old.
Craftmaster brand manufacture
Industry average life for an
electric water heater is 7 years.

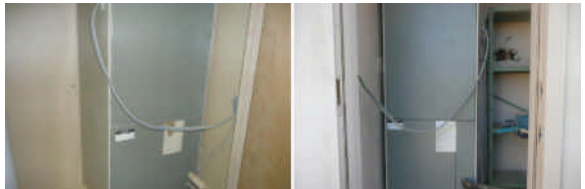
b) Both compressors observed to be newer models, 2 and 7 years old, however air handlers observed to be original, 20 and 21 years old.

HVAC Air handlers laundry /south closet

Recommend further evaluation by a licensed contractor and repair/replace air handlers if required

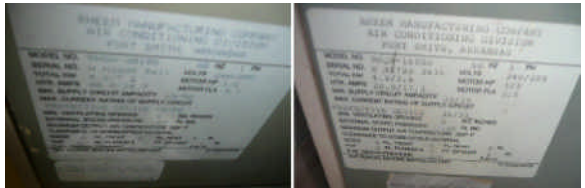
9.6 and 4.8 KW ratings

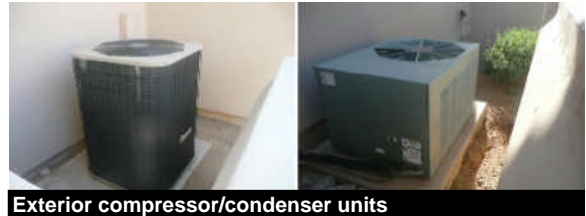
c) Deteriorated/Missing Cold Line insulation observed at south side by the compressor/condenser unit. Recommend repair.

Exterior compressor/condenser units

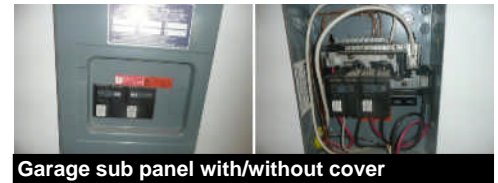
Garage sub panel with/without cover

SUB PANEL NOTES: #1 Circuit and wire sizing correct so far as visible
Grounding system is present. Observed in good condition.

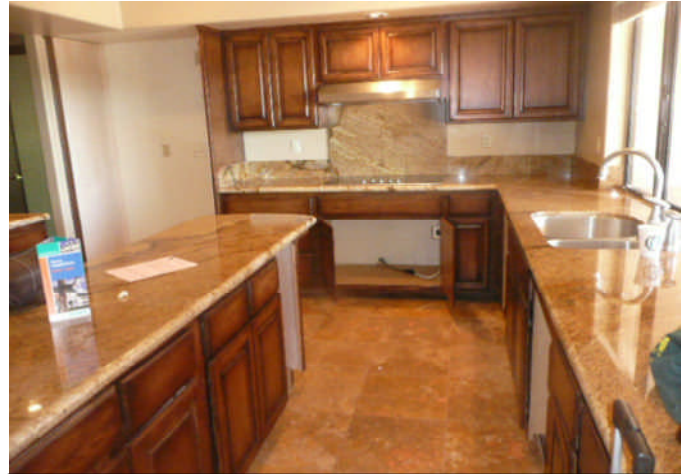
Kitchen view and condition at inspection

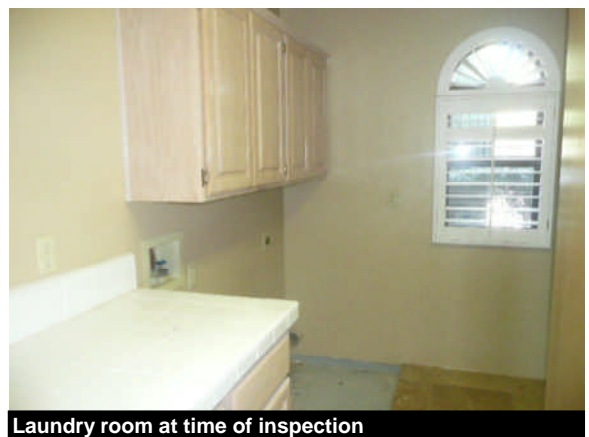
Laundry room at time of inspection

CONDITION: Plumbing tested in good condition. No leaks or damages observed.

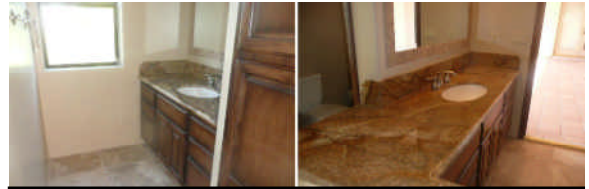
Master bath sinks at inspection

CONDITION OF SINK Number of sinks: Two sinks. Both Sinks observed in good condition. Faucets tested operable. Good water flow and no signs of leaks or damages observed. Drainage tested operable. Good flow observed. No damage or leaks observed. Counters observed in good condition. Bathroom cabinets observed in good condition. Tested operable.

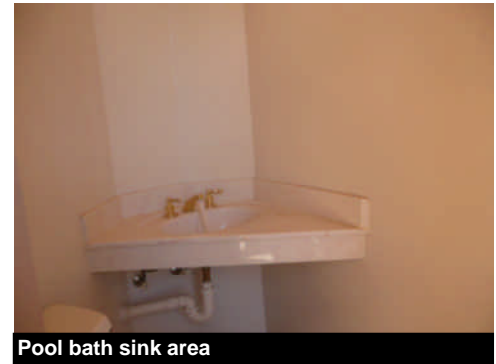
Pool bath sink area

CONDITION OF SINK Number of sinks: One sink
Sink observed in good condition.
Faucets tested operable. Good water flow and no signs of leaks or damages observed.
Drainage tested operable. Good flow observed. No damage or leaks observed.

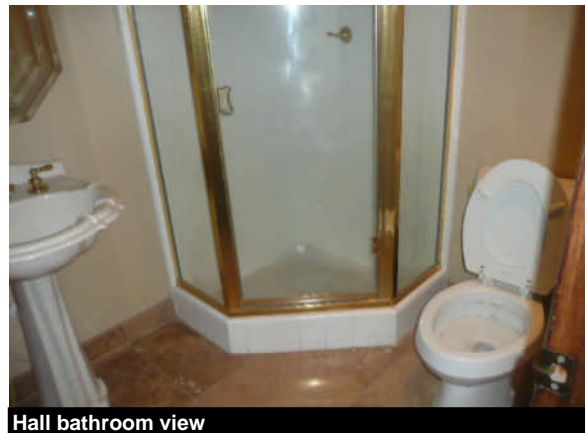
Hall bathroom view

CONDITION OF SINK Number of sinks: One sink
Sink observed in good condition.
Faucets tested operable. Good water flow and no signs of leaks or damages observed.
Drainage tested operable. Good flow observed. No damage or leaks observed.

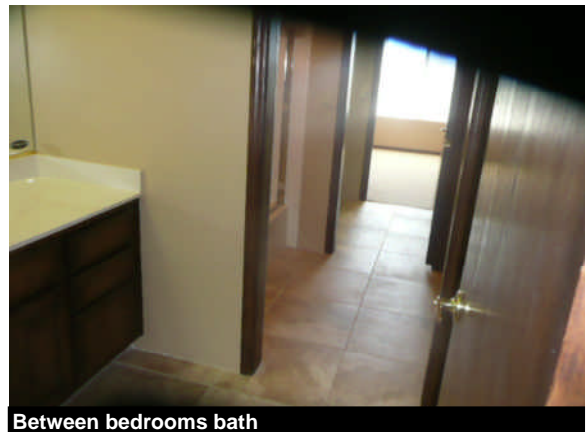
Number of sinks: Two sinks
Sink(s) observed in good condition.
Faucets tested operable. Good water flow and no signs of leaks or damages observed.
Drainage tested operable. Good flow observed. No damage or leaks observed.
Counters observed in good condition.
Bathroom cabinets observed in good condition. Tested operable.
